**ORPINGTON AND DISTRICT ARCHAEOLOGICAL SOCIETY**

**SCADBURY MOATED MANOR,  
CHISLEHURST, BR7 6LN**

**BRICKWORK CONSERVATION  
WATCHING BRIEF REPORT**

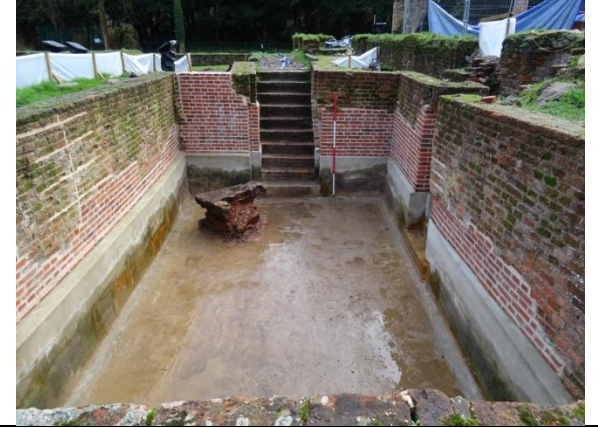
**6.1.1** Pierra staff drained the water and sediment from the base of the cellar, removed vegetation from the walls and removed the earth and rubble from the spiral staircase. On removing the water and sediment a sump was found in the north east corner which had no drain to it to take water away. Acro props were installed to make the area safe for people to work in.

| <p><b>Large cellar 2021; acro props installed</b></p> | <p><b>Large cellar 2022; completed</b></p> |

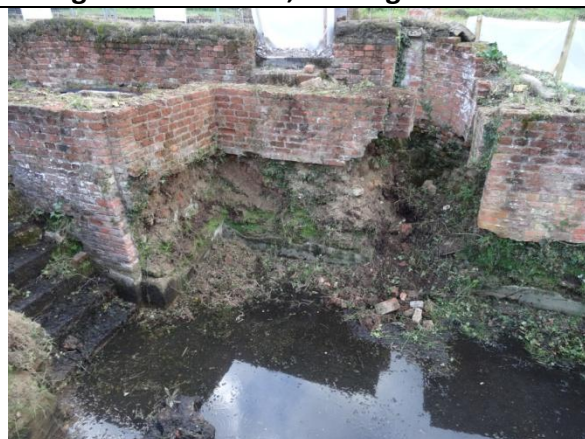
**Cellar 2021 south west corner before work**

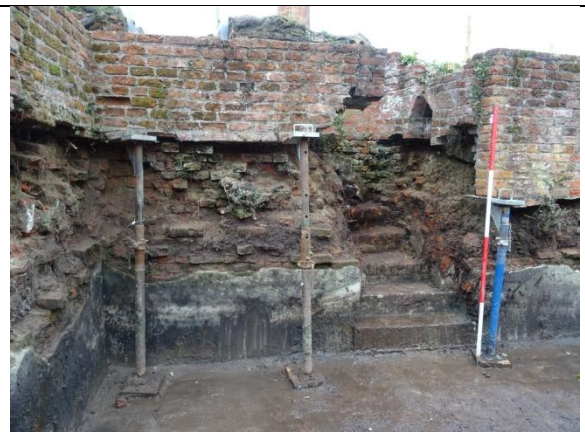
**Cellar 2021 south west corner before work**

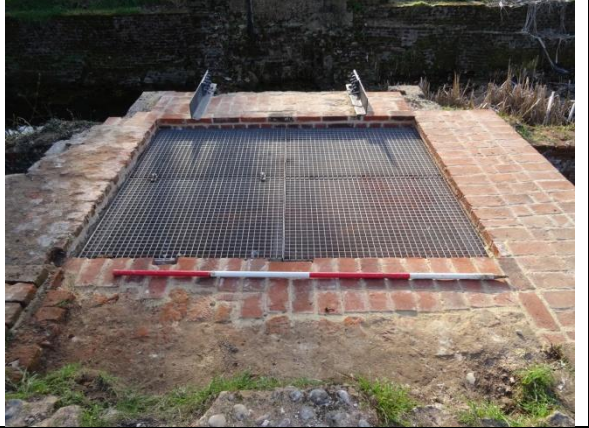
| <b>Drawbridge pit 2021; looking west before work</b> | <b>Grating in position 2022</b> |

6.2.1 Scaffolding was installed inside the pit. Pierra staff removed vegetation from the brickwork. Loose brickwork was removed and new brickwork installed. The metal supports to the drawbridge were painted by Pierra staff to protect them. A new grating was installed at the top of the pit for safety.

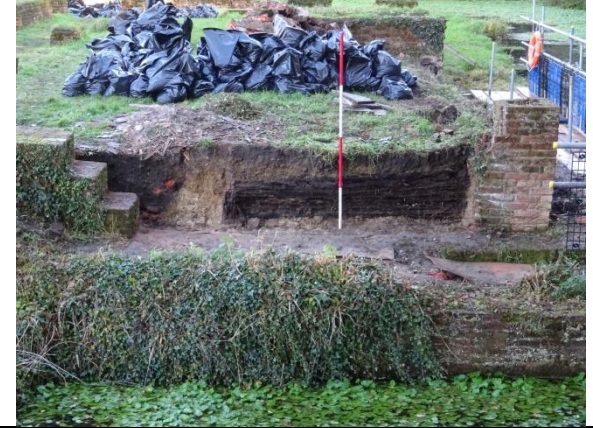
| <p><b>South west island (A-C) with temporary propping in place before work</b></p> | <p><b>South west (A-C) showing wooden shuttering</b></p> |

6.3.1 The 1920s single width brickwork, in which cement was used, was taken down by Pierra staff to reveal a wooden revetment behind. Pierra staff removed this wooden revetment and loose soil behind that so that the earth bank was exposed. The bank was cut back to allow space for the new double width wall to be built.

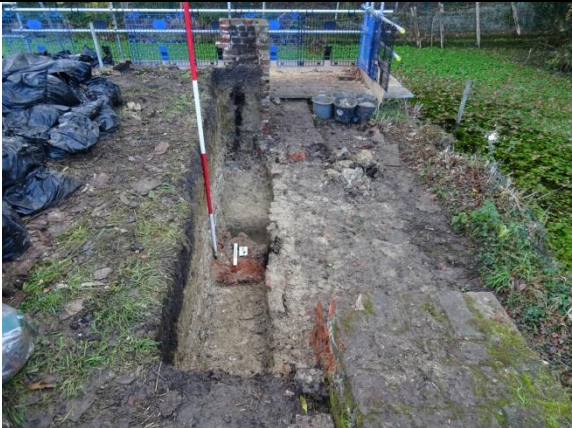
6.3.4 As the new foundations had to be slightly deeper than the previous wall more earth had to be removed from the bottom of the trench. This revealed the foundations of a Tudor wall with lime mortar going in an easterly direction, which was recorded. On top of this Tudor wall the earth bank had layers of earth running right across it with no cut for the wall.

| <p><b>Remains of foundations of Tudor wall (A-C)</b></p> | <p><b>Tudor wall foundations in section (B-C)</b></p> |

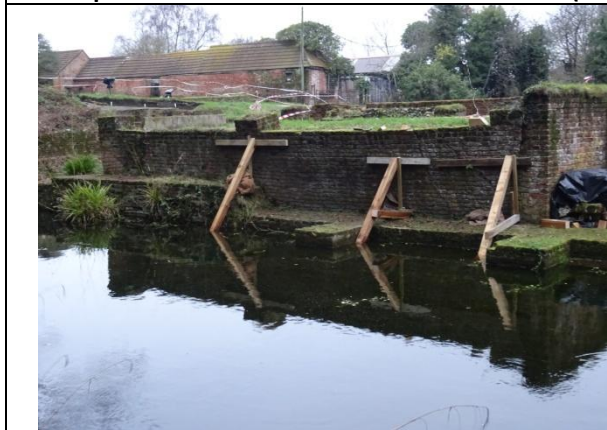
**South western end of south wall (D-E) with temporary props in place before work 2021**

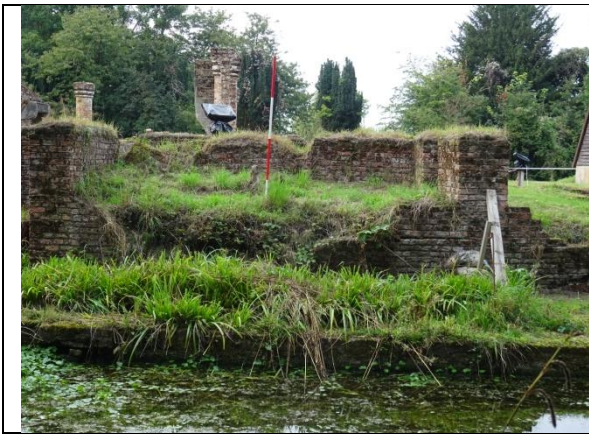
**Middle of south wall (F-G) showing collapsed brickwork and temporary prop before work 2021**

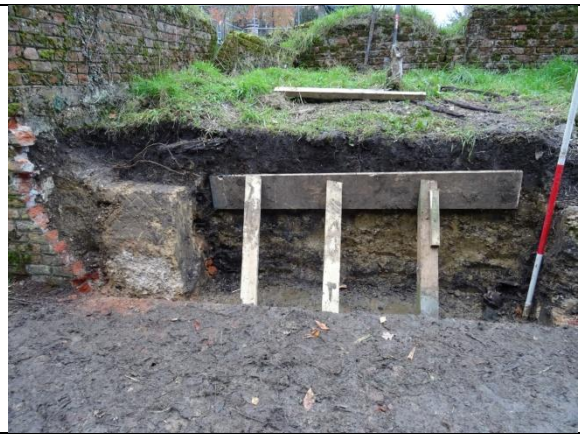
**Earth bank (F-G) being supported during work**

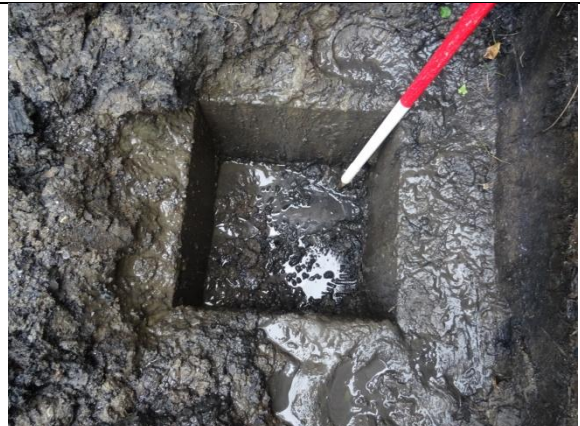
**Close up of sump**

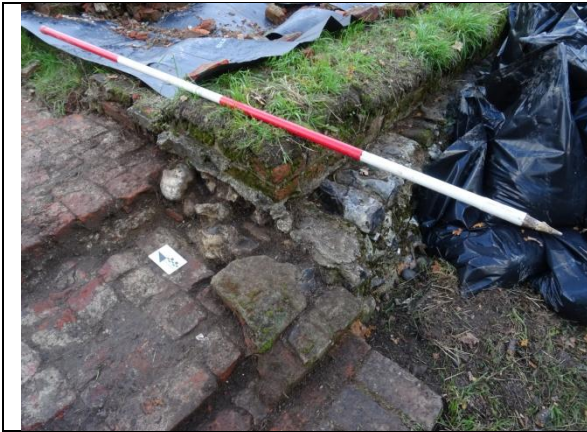
6.2.3 By looking at the conjunction of the end of the flint wall that goes towards the hall and the brickwork by the pit ODAS found that the bricks have been cut to meet the flint wall. This shows that the flint wall was there before the brickwork of the drawbridge pit was constructed.

**Flint wall by drawbridge pit**

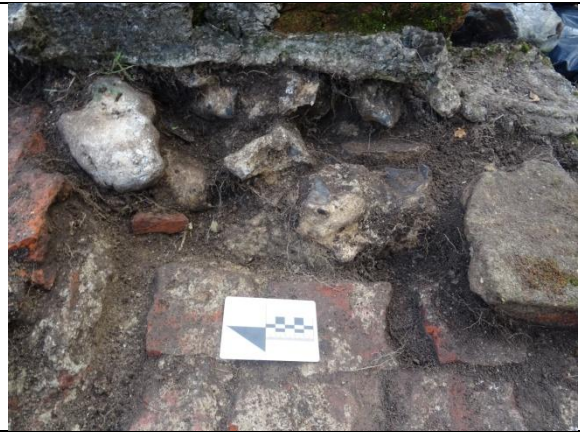
**Tudor brickwork next to flint wall**

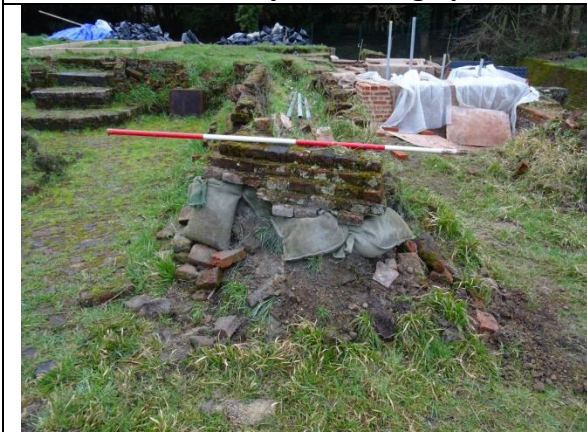
**Area 1 sand bags inserted under wall**

8.3 Loose brickwork around the drawbridge pit was removed and new brickwork and metal grating installed. Other brickwork in area 1 and the north moat wall had sandbags inserted to stabilise the brickwork.

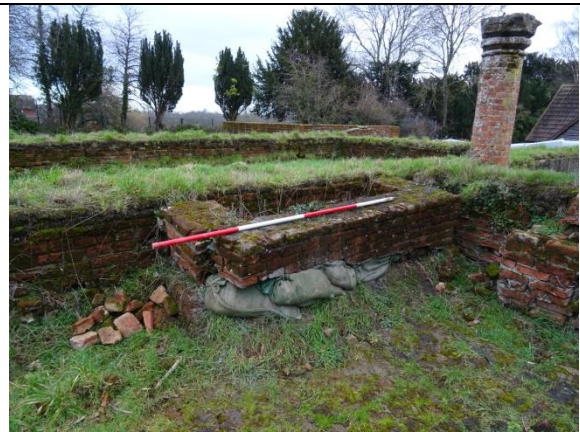
**Area 1 sand bags inserted under wall**

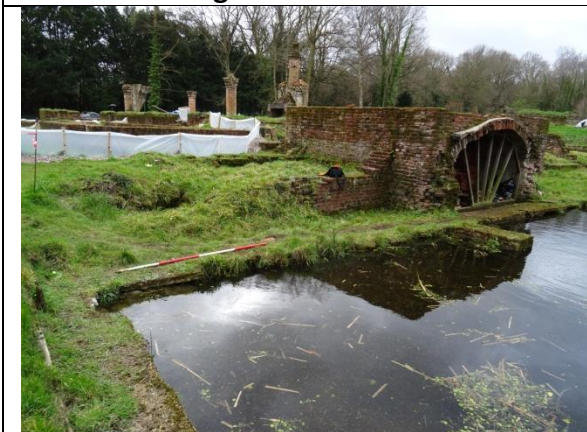
**North island; sand bags inserted under wall**

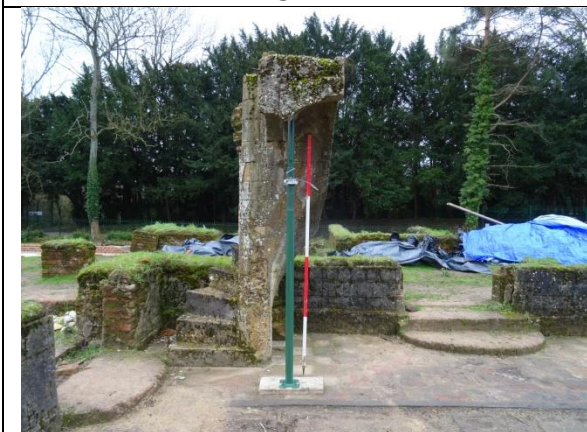
**Hall; Acro Prop inserted to support stairs**
