**ORPINGTON AND DISTRICT ARCHAEOLOGICAL SOCIETY**

**SCADBURY MOATED MANOR,  
CHISLEHURST, BR7 6LN**

**BRICKWORK CONSERVATION  
WATCHING BRIEF REPORT**

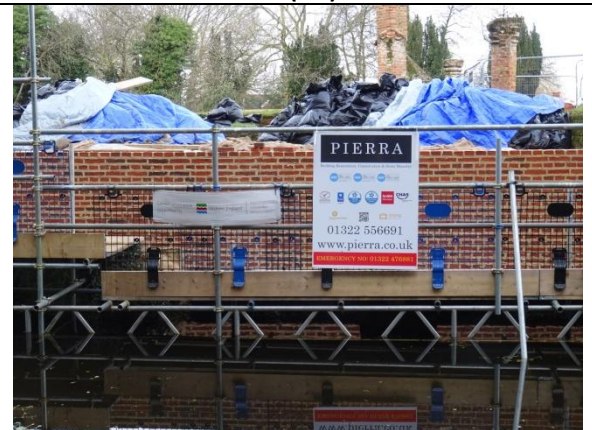
**South wall (D-E) during work 2022**

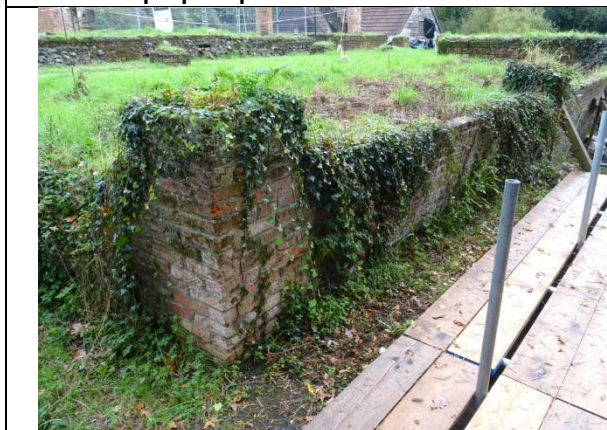
**South west corner (D-E) before work 2021**

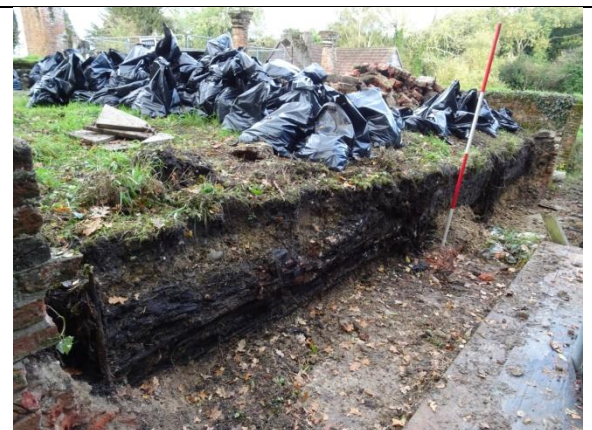
**Wooden shuttering (D-E) after wall removed**

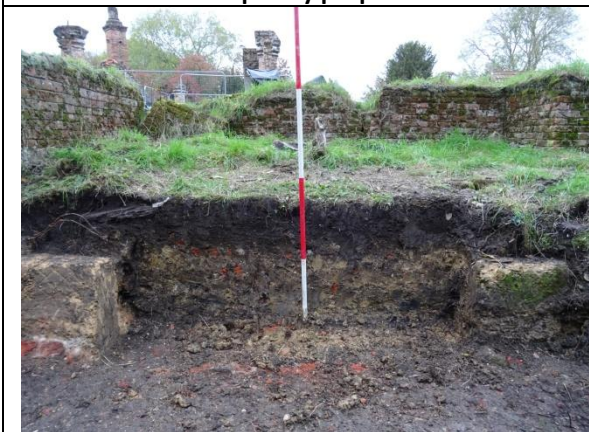
**South wall (F-G) 1920s shuttering removed 2021**

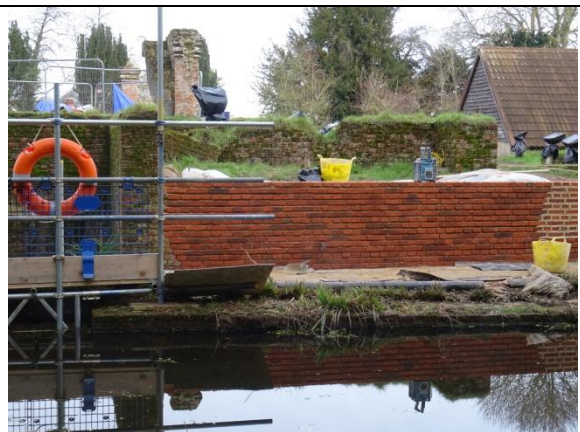
**Middle of south wall (F-G) after work 2022**

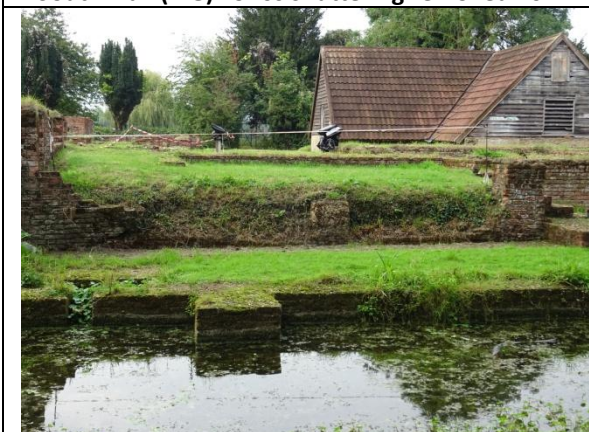
**South eastern wall (H-I) before work 2021**

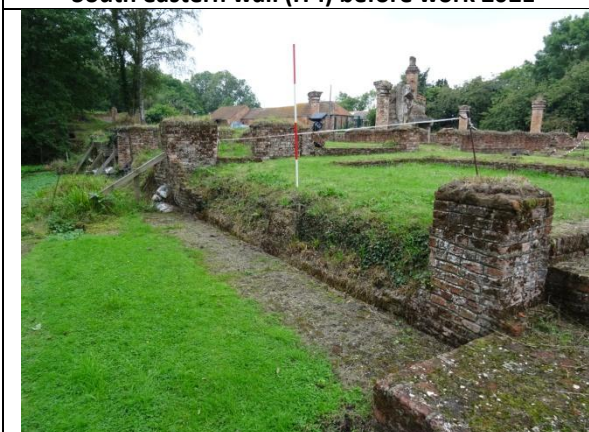
**South eastern wall (H-I) before work 2021**

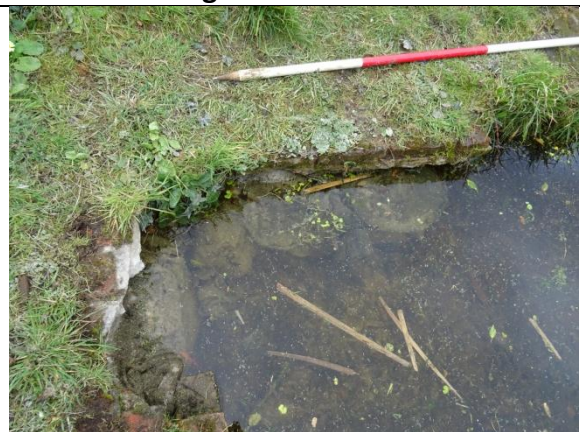
**Close up sand bags inserted to support wall**

8.3 Loose brickwork around the drawbridge pit was removed and new brickwork and metal grating installed. Other brickwork in area 1 and the north moat wall had sandbags inserted to stabilise the brickwork.

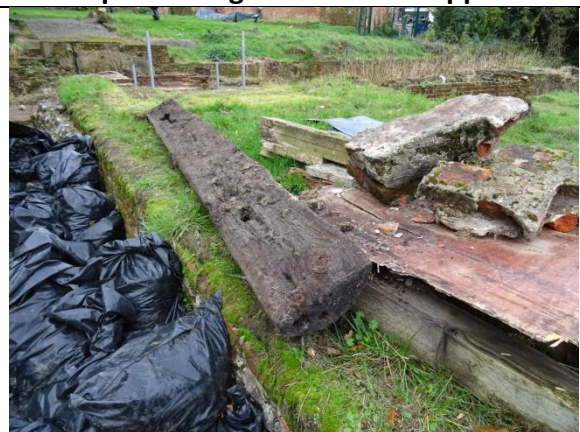
**Wooden shuttering from the south wall**
