**ORPINGTON AND DISTRICT ARCHAEOLOGICAL SOCIETY**

**SCADBURY MOATED MANOR,  
CHISLEHURST, BR7 6LN**

**BRICKWORK CONSERVATION  
WATCHING BRIEF REPORT**

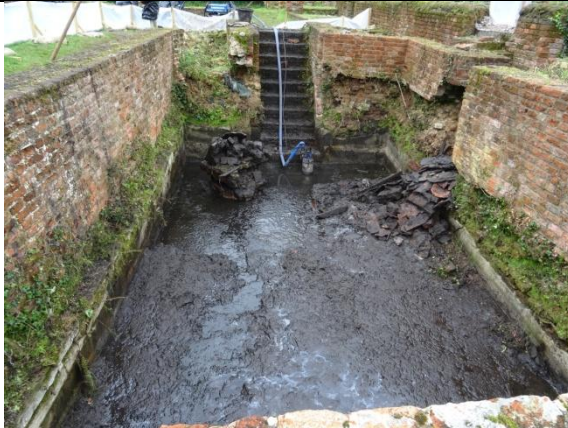
**6.1.1** Pierra staff drained the water and sediment from the base of the cellar, removed vegetation from the walls and removed the earth and rubble from the spiral staircase. On removing the water and sediment a sump was found in the north east corner which had no drain to it to take water away. Acro props were installed to make the area safe for people to work in.

| <p><b>Large cellar 2021; water pumped out</b></p> | <p><b>Large cellar 2021; half of sediment removed</b></p> |

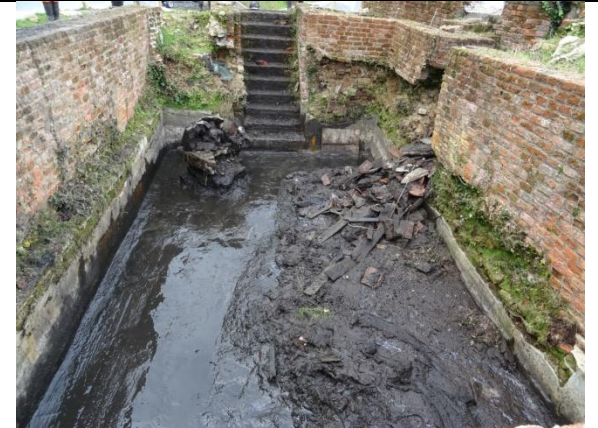
**6.1.2** While Pierra staff removed the sediment from the cellar ODAS looked through it and recovered any finds. Once the loose brickwork in the cellar was removed ODAS inspected it and found that the Tudor wall on the east side continued south as well as turning west towards the south staircase. Behind the walls of that staircase were the foundations of an earlier Tudor staircase. This staircase led towards the kitchen. Next to this staircase on the west side are the remains of an arch which went over the entrance to the staircase. When some loose brickwork was removed from the west side of the south staircase a 1920s drain could be seen which runs from the concrete pit next to the hall into the side of the stairs.

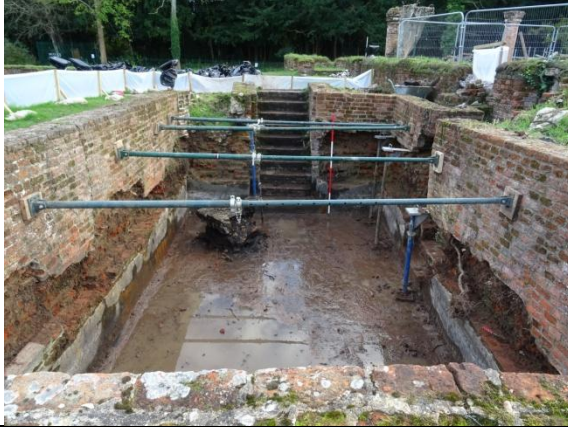
| <p><b>Large cellar 2021; acro props installed</b></p> | <p><b>Large cellar 2022; completed</b></p> |

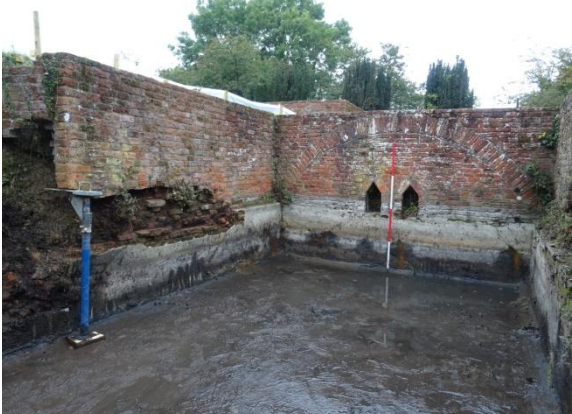
| <b>Large Cellar 2021; north side before work</b> | <b>Large cellar 2022; after work completed</b> |

the 1920s brickwork. The majority of the Tudor and 1920s brickwork was left in situ and new bricks were installed where the loose bricks and vegetation had been removed to make the cellar safe. HeliBars were installed where there were cracks in the remaining 1920s brickwork.

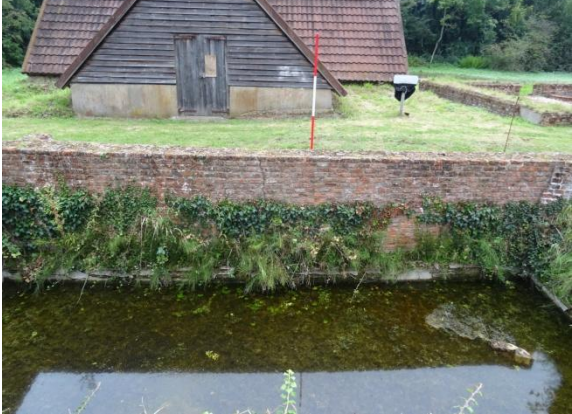
| <b>Large cellar 2021; east side before work</b> | <b>Large cellar 2022; after work completed</b> |

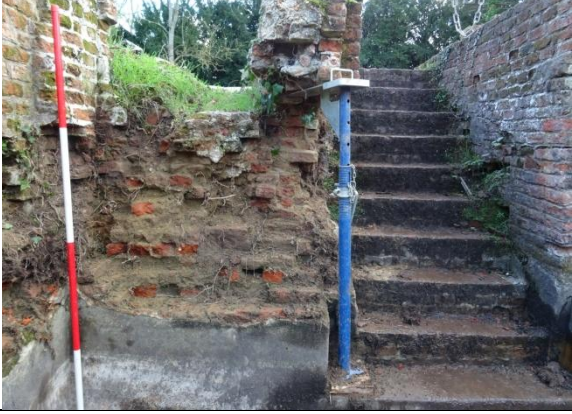
| <b>Large cellar; south east corner before work</b> | <b>Large cellar 2022; after work completed</b> |

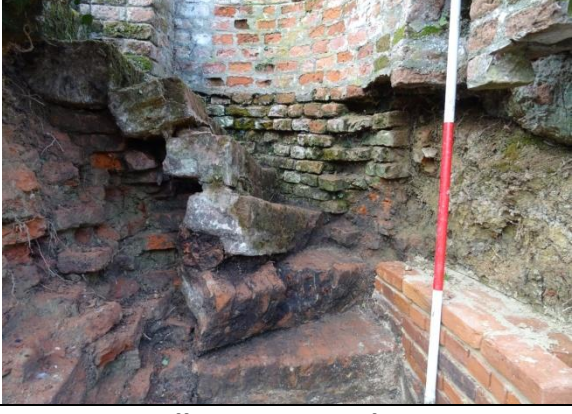
**6.1.3** On the west side of the cellar, once the earth and rubble were removed from the spiral staircase and the loose brickwork removed, ODAS cleaned the steps and brickwork to see how the staircase was constructed. On inspection it was found that under the 1920s brick and concrete stairs were the remains of the original Tudor spiral stairs. Once the niches on the south wall were cleaned it was found that they were constructed of Tudor bricks, behind

| <b>Large cellar 2021; spiral staircase</b> | <b>1920s stairs on top of Tudor stairs</b> |

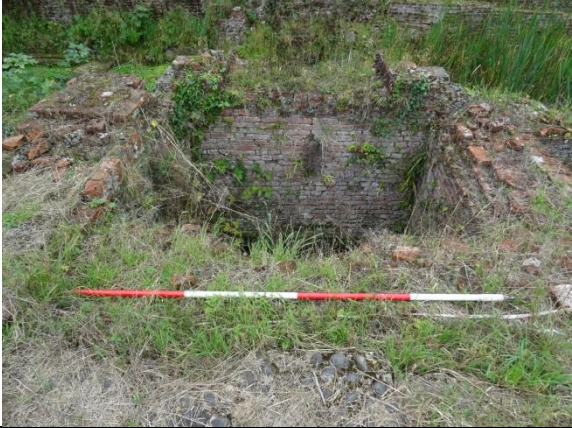
| <b>Drawbridge pit 2021; looking west before work</b> | <b>Grating in position 2022</b> |

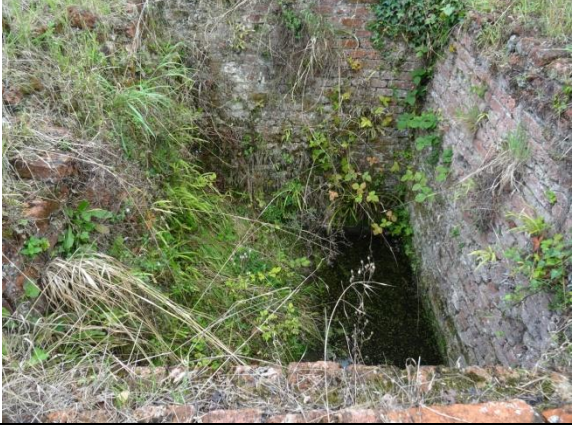
| <b>Drawbridge pit before work looking south</b> | <b>Drawbridge pit 2021; during work</b> |

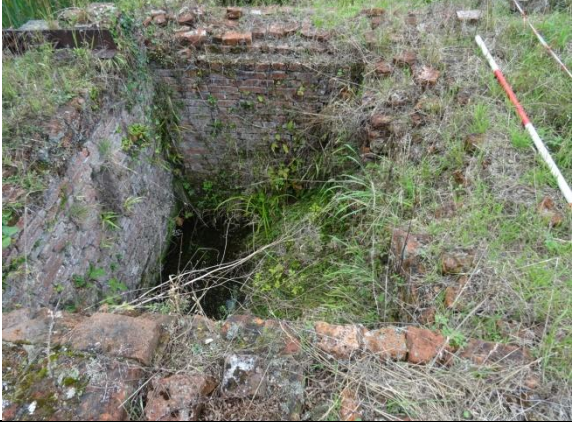
| <b>Drawbridge pit before work looking north</b> | <b>Grating supports and scaffolding 2022</b> |

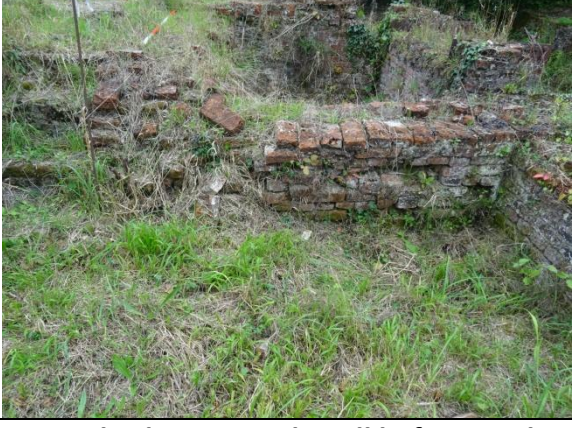
| <b>Drawbridge pit north wall before work</b> | <b>Drawbridge pit 2022; after work</b> |

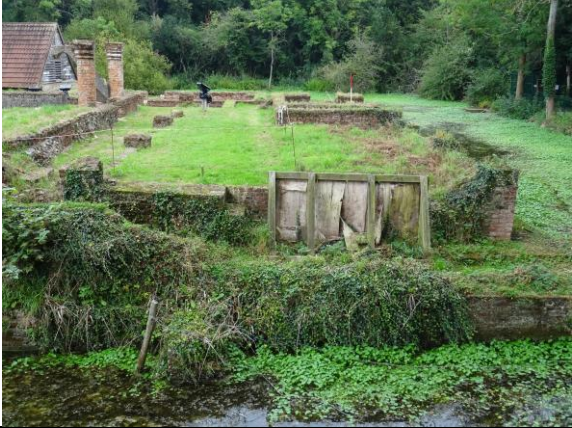
| <p><b>South west island (A-C) with temporary propping in place before work</b></p> | <p><b>South west (A-C) showing wooden shuttering</b></p> |

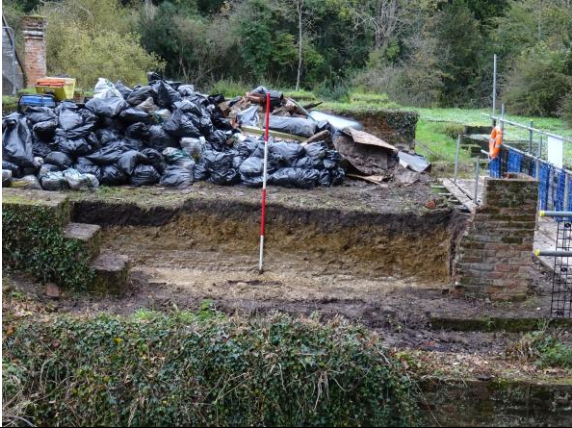
| <p><b>(A-C) Wooden shuttering removed</b></p> | <p><b>South west wall (A-C) 2022; after work</b></p> |

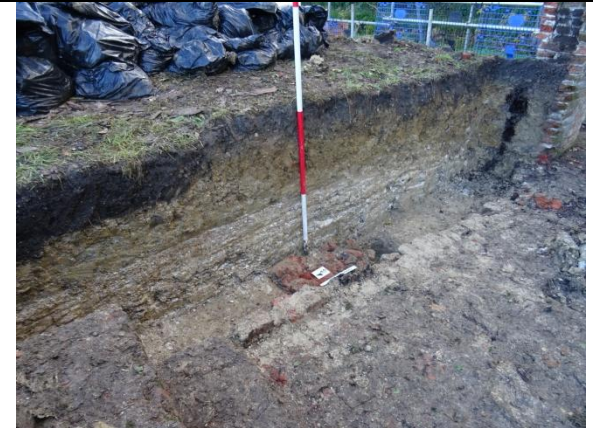
| <p><b>Remains of foundations of Tudor wall (A-C)</b></p> | <p><b>Tudor wall foundations in section (B-C)</b></p> |

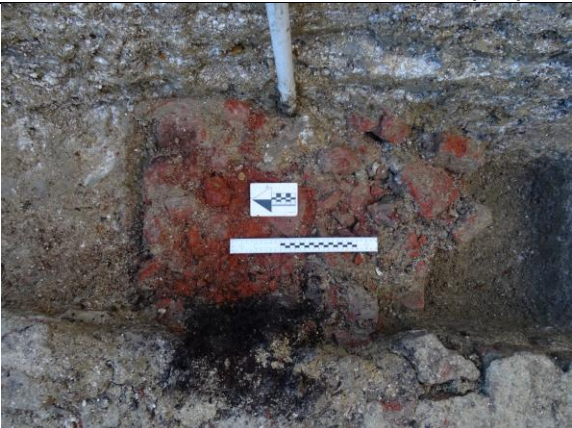
| <p><b>Top of Tudor wall foundations (B-C)</b></p> | <p><b>Side view of Tudor wall foundations (B-C)</b></p> |

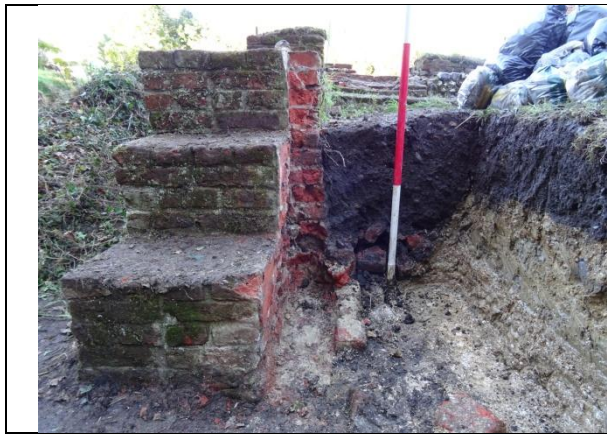
**West wall (A-B) showing earlier excavation by stairs**

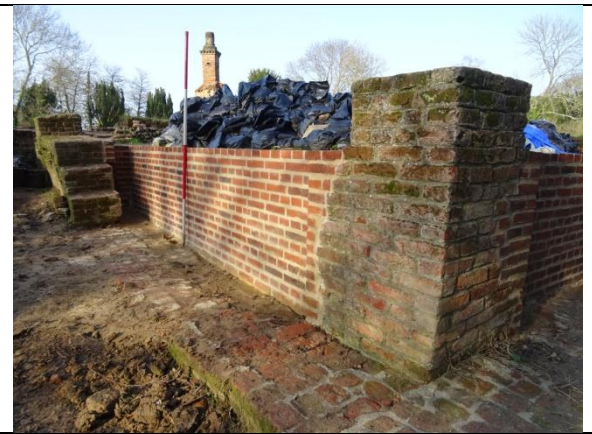
**West wall (A-C) after work 2022**

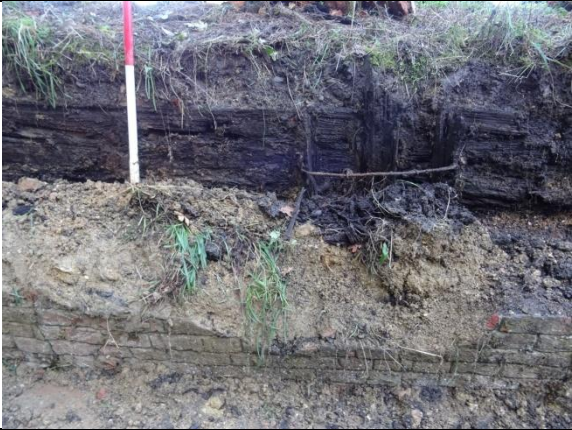
| <p><b>South wall (D-E) wooden post with shuttering</b></p> | <p><b>Metal staple from shuttering</b></p> |

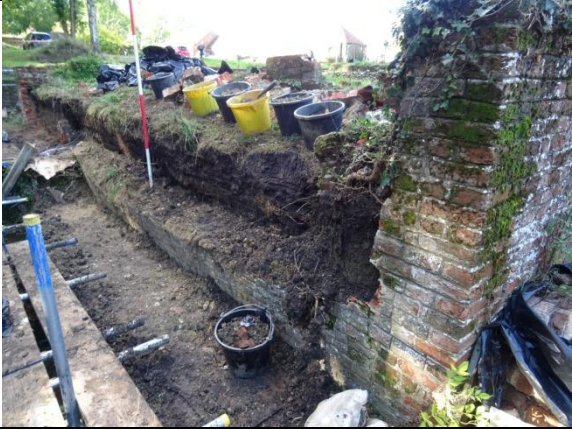
| <p><b>Part of brick wall removed with shuttering behind (D-E)</b></p> | <p><b>Brick wall (D-E) removed showing shuttering</b></p> |

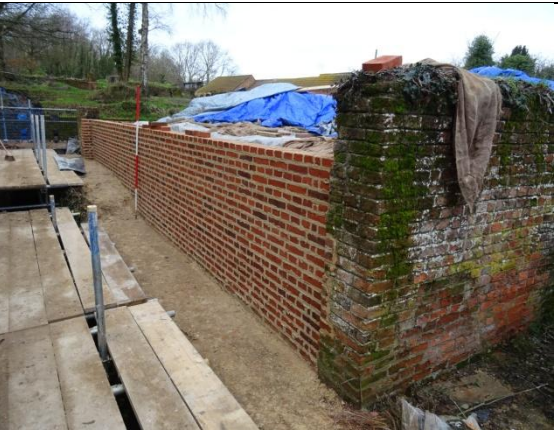
| <p><b>Shuttering (D-E) removed 2021</b></p> | <p><b>South wall (D-E) after work 2022</b></p> |

8.2 The brickwork on the south west wall was taken down to reveal a wooden revetment and under that were the foundations of an unknown Tudor wall going in an easterly direction. A new brick wall was built. The brickwork on the south side was taken down to reveal a wooden revetment which was also removed. A new brick wall was built.
